Support Bulletin-SB-25-10045

Title: O-Ring Missing Between PWM Valve Block & Hydraulic Motor

Product Line: FAS

Model: 164-FTA1609

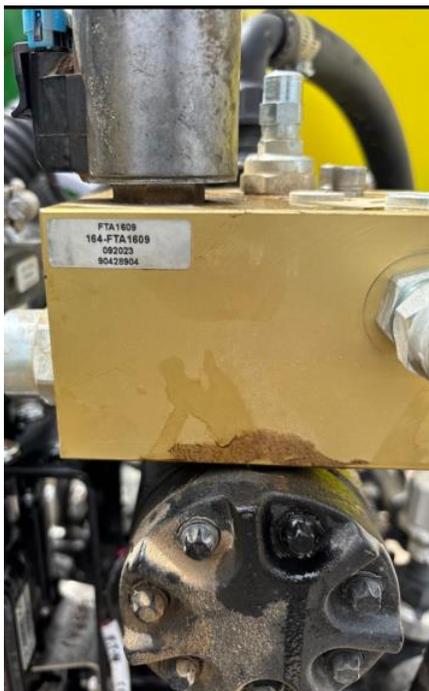
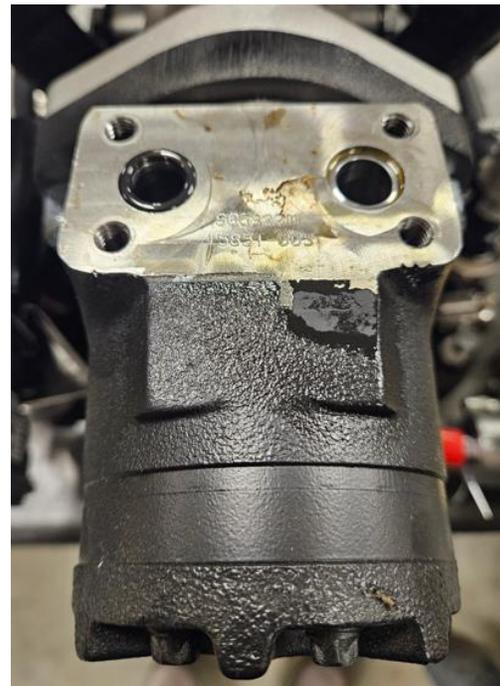
Overview: A batch of 164-FTA1609 PWM Valve/Motor assemblies were assembled incorrectly from the vendor and are missing either 1 or both o-rings that sit in between the PWM block and hydraulic motor. With 1 or both o-rings missing the assembly will leak hydraulic oil from between the two pieces.

Each motor requires two o-rings. SurePoint will warranty two o-rings and overnight ship them to the customer. These o-rings are a standard size that can also be sourced locally if the customer prefers. The SurePoint part number and description is:

166-ORING-112 (112 Buna 70 Duro O-Ring, Between Eaton Motor & Hydraulic Block (2 per motor))
