Support Bulletin-SB-25-10019

Title: Sentinel 1.6.0 Harness Identifier Loads Incorrectly

**Product Line: FAS**

**Model: Sentinel Software**

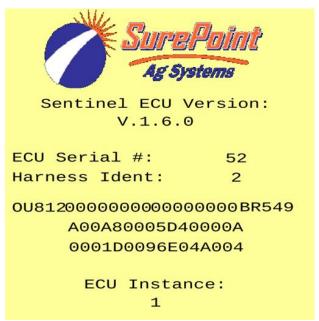
Overview: When updating both Sentinel 1000 & Sentinel 2000 software to version 1.6.0, once updated on the software page the Harness Ident: may show 2. This will be the case for a limited number of ECU's sent out before we caught the issue. The current software on the support site will load this correctly. Some symptoms that have been seen in the field are pressure not working on a setup. For the majority of SurePoint harnessing this should be set to 0. Some harnesses will change this to 1 when they are plugged in. There is no scenario where this should ever be a 2.

For a limited number of ECU's Harness Ident: may load as 2

when installing 1.6.0 software.
